International scientific and practical conference
ENERGY SYSTEMS AND ALTERNATIVE ENERGY SOURCES '2025 (ESAES – 2025)

National Technical University “Kharkiv Polytechnic Institute”
Department of Heat Engineering and Energy-Efficient Technologies

Analysis of the thermal stress state of the ICE piston skirt in critical cases

Kharkiv , March 11-12, 2025

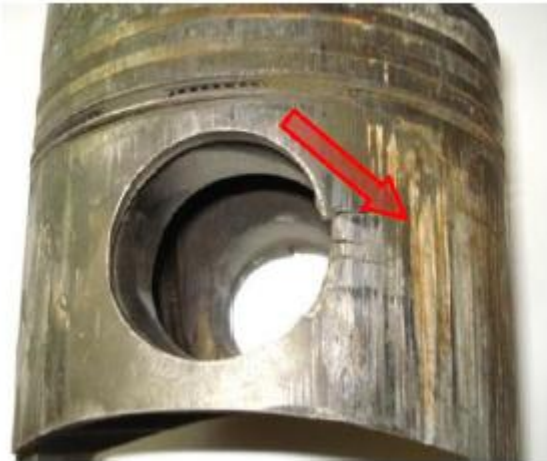
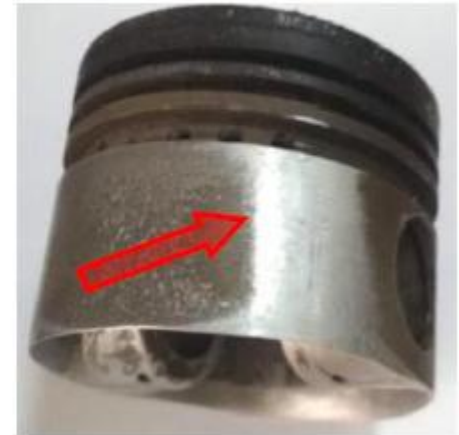
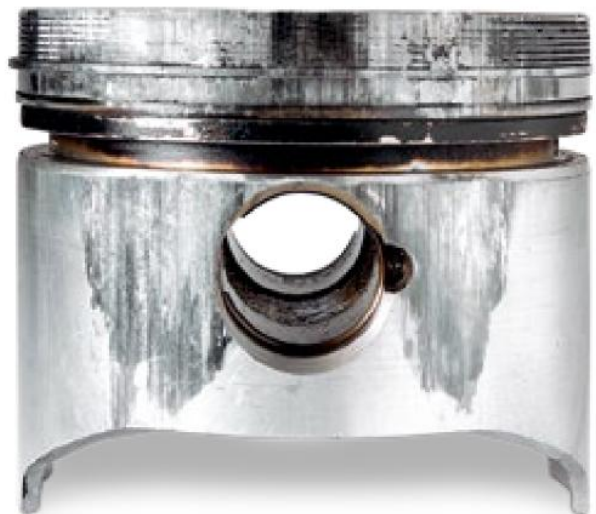
Scuffing and seizures on the outer surface of the piston skirt
on both the pressure and anti-thrust sides

The cause of such damage is considered to be overheating of the piston pin bed in the piston bosses due to:

- mechanical overload of the connecting rod bearing caused by combustion process deviations
- failure of the lubrication due to malfunction of the oil jet nozzle or insufficient pressure created by the oil pump
- insufficient lubrication during the initial engine startup

The location of critical areas of the skirt in the event of a fault emerging has been determined. Simulation results are in full correlation with the observations in ICE maintenance practice regarding the places of occurrence of scuffing and seizures on the piston skirt, as well as with the proposed explanation of the reasons for the loss of reliability.
